# Analysis of Cross-Bores in Unmarked Sewer Service Laterals

Samuel T. Ariaratnam, M.ASCE<sup>1</sup>

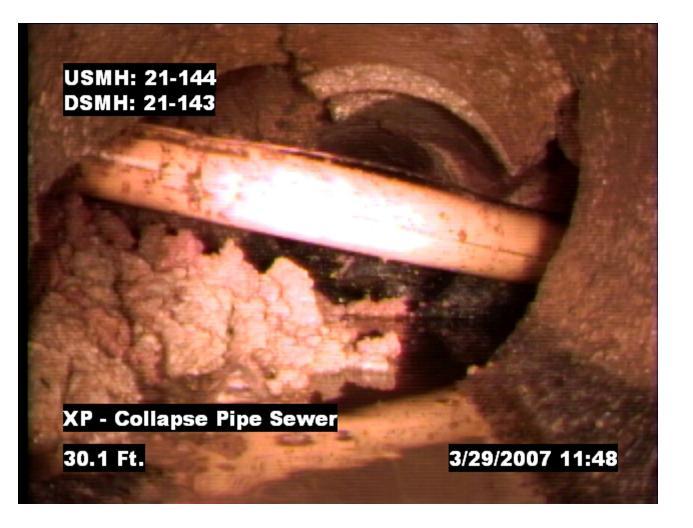
**Fig. 1.** Cross-bore of a natural gas distribution line in a sewer service lateral

The underground utility industry is facing some unique challenges as a result of unmarked sewer service laterals. With an increase in trenchless methods, such as the use of horizontal directional drilling (HDD) and pneumatic piercing tools, unmarked laterals present a risk of accidental and unknown natural gas cross-bores with distribution lines (Bruce 2012). Although the physical damage to underground facilities is always unwanted, a natural gas distribution line that intersects a sewer lateral is vulnerable to mechanized sewer cleaning tools that may be used in the event of a backup, with potential explosive consequences. Fig. 1 illustrates a typical crossbore of a natural gas line in a sewer service lateral from a closed circuit television (CCTV) camera inspection.

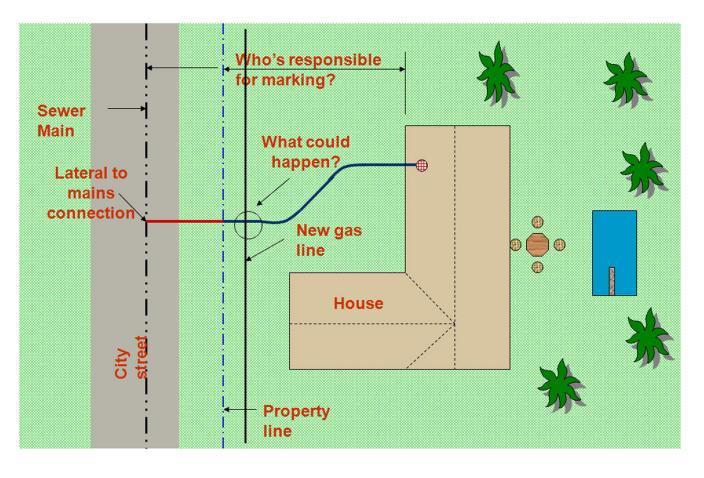
Fig. 2. Typical scenario involving sewer service laterals on private property

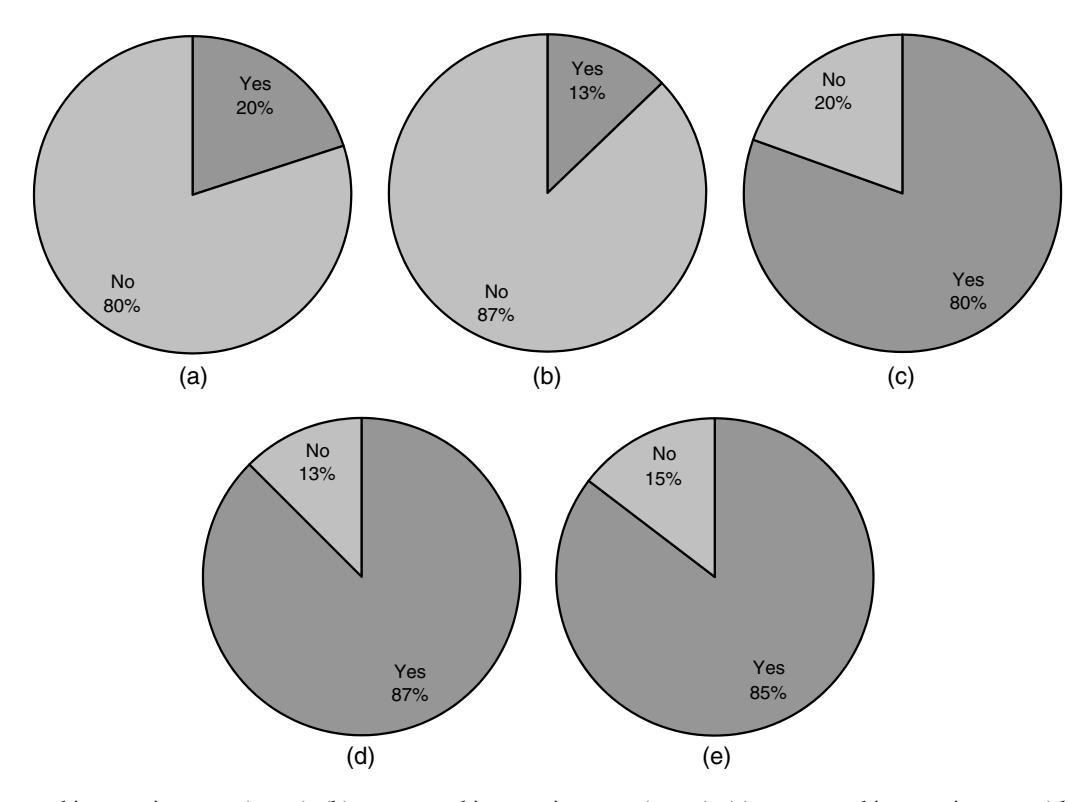
**Fig. 3.** (a) Owner marking requirements (water); (b) owner marking requirements (sewer); (c) owner marking requirements (electrical); (d) owner marking requirements (natural gas); (e) owner marking requirements (communications)

The respondents were asked about their experiences with owners of underground infrastructure in areas where they did business with regard to marking their utilities. Fig. 3 provides a percentage breakdown of requirements for locating and marking based on (1) water to the building (20%); (2) sewer to the building (13%); (3) electrical to the building/meter (80%); (4) natural gas to building/meter (87%); and (5) communication to building (85%). Not surprisingly, owners of electrical, natural gas, and communication infrastructure were typically required to mark their facilities. However, it is alarming that owners of water and sewer infrastructure were generally not required to mark their facilities. Sewer service laterals are typically composed of nonmetallic material, subsequently creating an additional challenge for locating and marking. It is also more difficult to detect the presence of a crossbore in a water or sewer service lateral compared with electrical and communication lines where the end user would immediately notice an interruption in service.

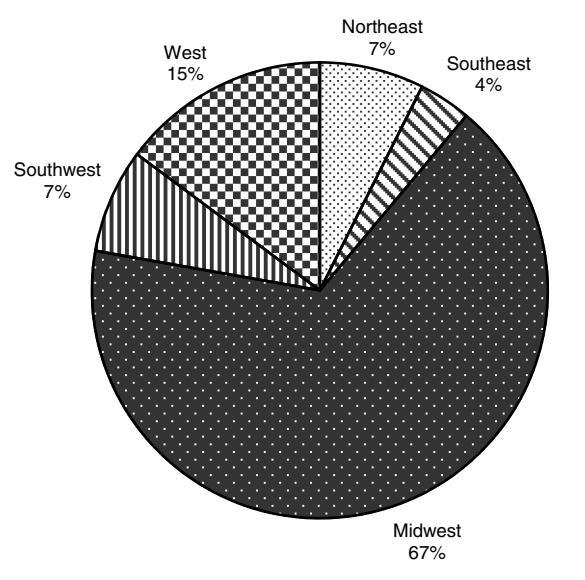
Fig. 8. Geographic location of recorded cross-bore incidents in the United States

In terms of geographic region where the respondents had knowledge of cross-bores, an overwhelming majority (67%) occurred in the Midwest region of the United States (Fig. 8). In one inspection program in an undisclosed midwestern municipality, approximately 11,000 sewer laterals were inspected using CCTV cameras. During the inspection, 250 cross-bores were uncovered. Although comprising only 2% of the inspected system, this is a low frequency, but highly consequential situation. Unnoticed natural gas cross-bores are ticking time bombs that could result in catastrophic circumstances. Another Midwestern town revealed 24 cross-bores during an inspection of a single four-block area. Fifteen percent of the respondents had knowledge of cross-bores in the Northeast region. The geographical representation of the survey respondents was fairly evenly distributed among the East (30%), Midwest (33%),

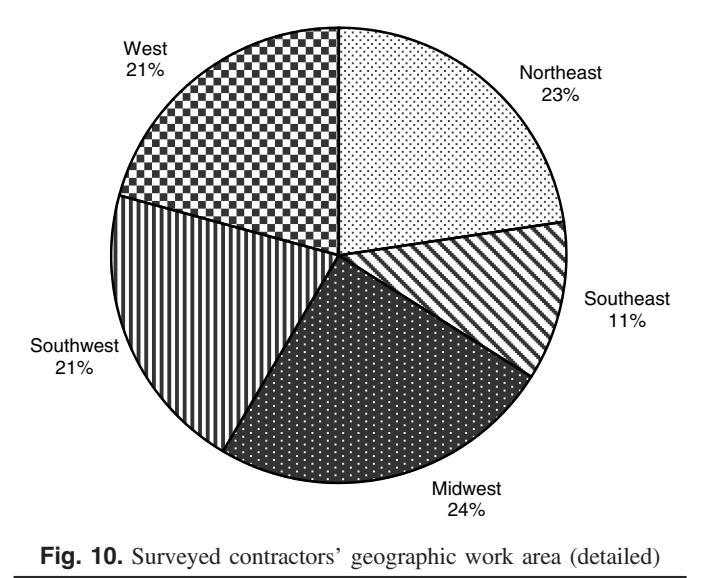
and West (37%) regions, as illustrated in Fig. 9. A further detailed breakdown of these regions is shown in Fig. 10.
